Manhole Inspection Summary

Manhole # S35K1_002MH

Location Address: **3001 S. Hanover St.**

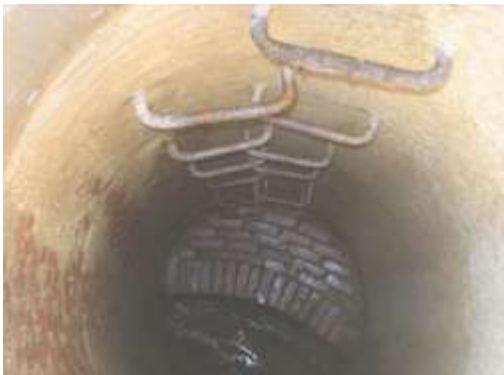
Steps

Count: **12** Missing: **0** ☒ **Corroded**

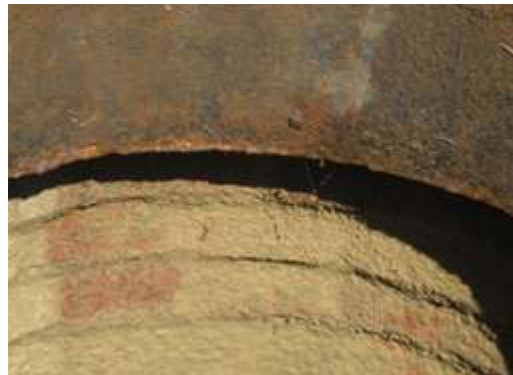
Defect 1

Offset: **2.5** (in.)

Frame Offset

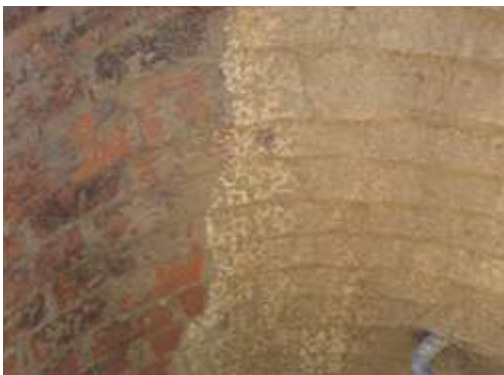
Defect 2

Infiltration: ☐ None ☐ Joint ☐ Cracks ☐ Mortar ☐ Roots ☒ **Wall**

Infiltration

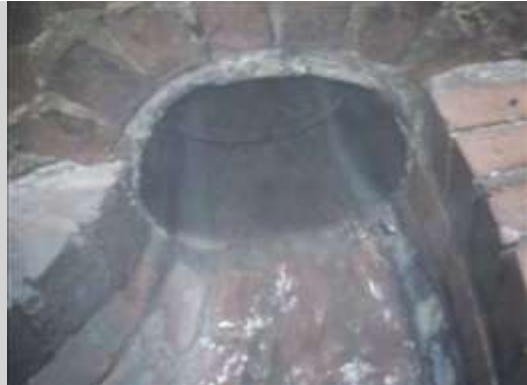
12 O'Clock Outflow

12 in. Circular Gravity Sewer
Pipe Out @ 12 O'Clock

Pipe Height: **12** (in.) Rod and Bar (Angled)
Pipe Material: **Clay** ☐ Pipe Lined
Invert Depth: **20.04** (ft.) Flow Characteristics: **Fast**
Deposits: ☒ None ☐ Mud ☐ Sludge ☐ Debris ☐ Grease
Silt Depth: (in.) Deposits Extent:
Infiltration: **None** Pipe Seal Cond: **Sound**

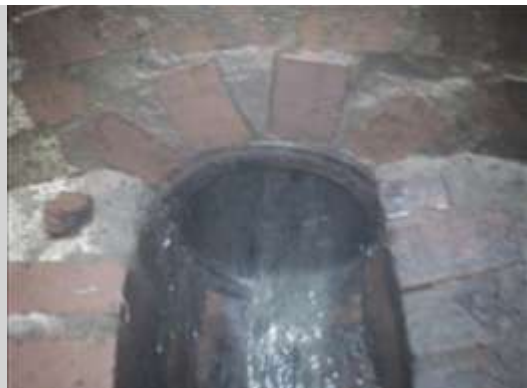
7 O'Clock Inflow

10 in. Circular Gravity Sewer
Pipe In @ 7 O'Clock

Pipe Height: **10.8** (in.) Rod and Bar (Angled)
Pipe Material: **Clay** ☐ Pipe Lined
Invert Depth: **19.73** (ft.) Flow Characteristics: **Fast**
Deposits: ☒ None ☐ Mud ☐ Sludge ☐ Debris ☐ Grease
Silt Depth: (in.) Deposits Extent:
Infiltration: **None** Pipe Seal Cond: **Sound**

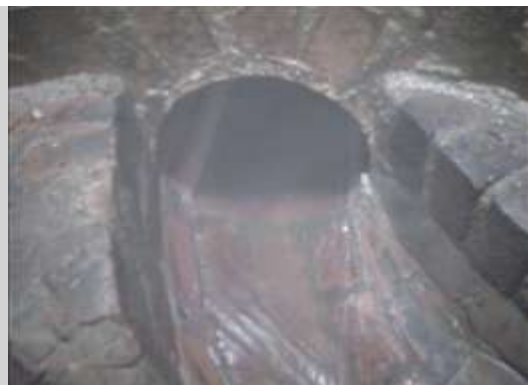
9 O'Clock Inflow

12 in. Circular Gravity Sewer
Pipe In @ 9 O'Clock

Infiltration: **None**

Pipe Seal Cond: **Sound**
